ARMY PRELIMINARY EVALUATION I.
RV-1D/QUICK LOOK II AIRCRAFT

Gary L. Bender, et al

Army Aviation Engineering Flight Activity
Edwards Air Force Base, California

August 1974

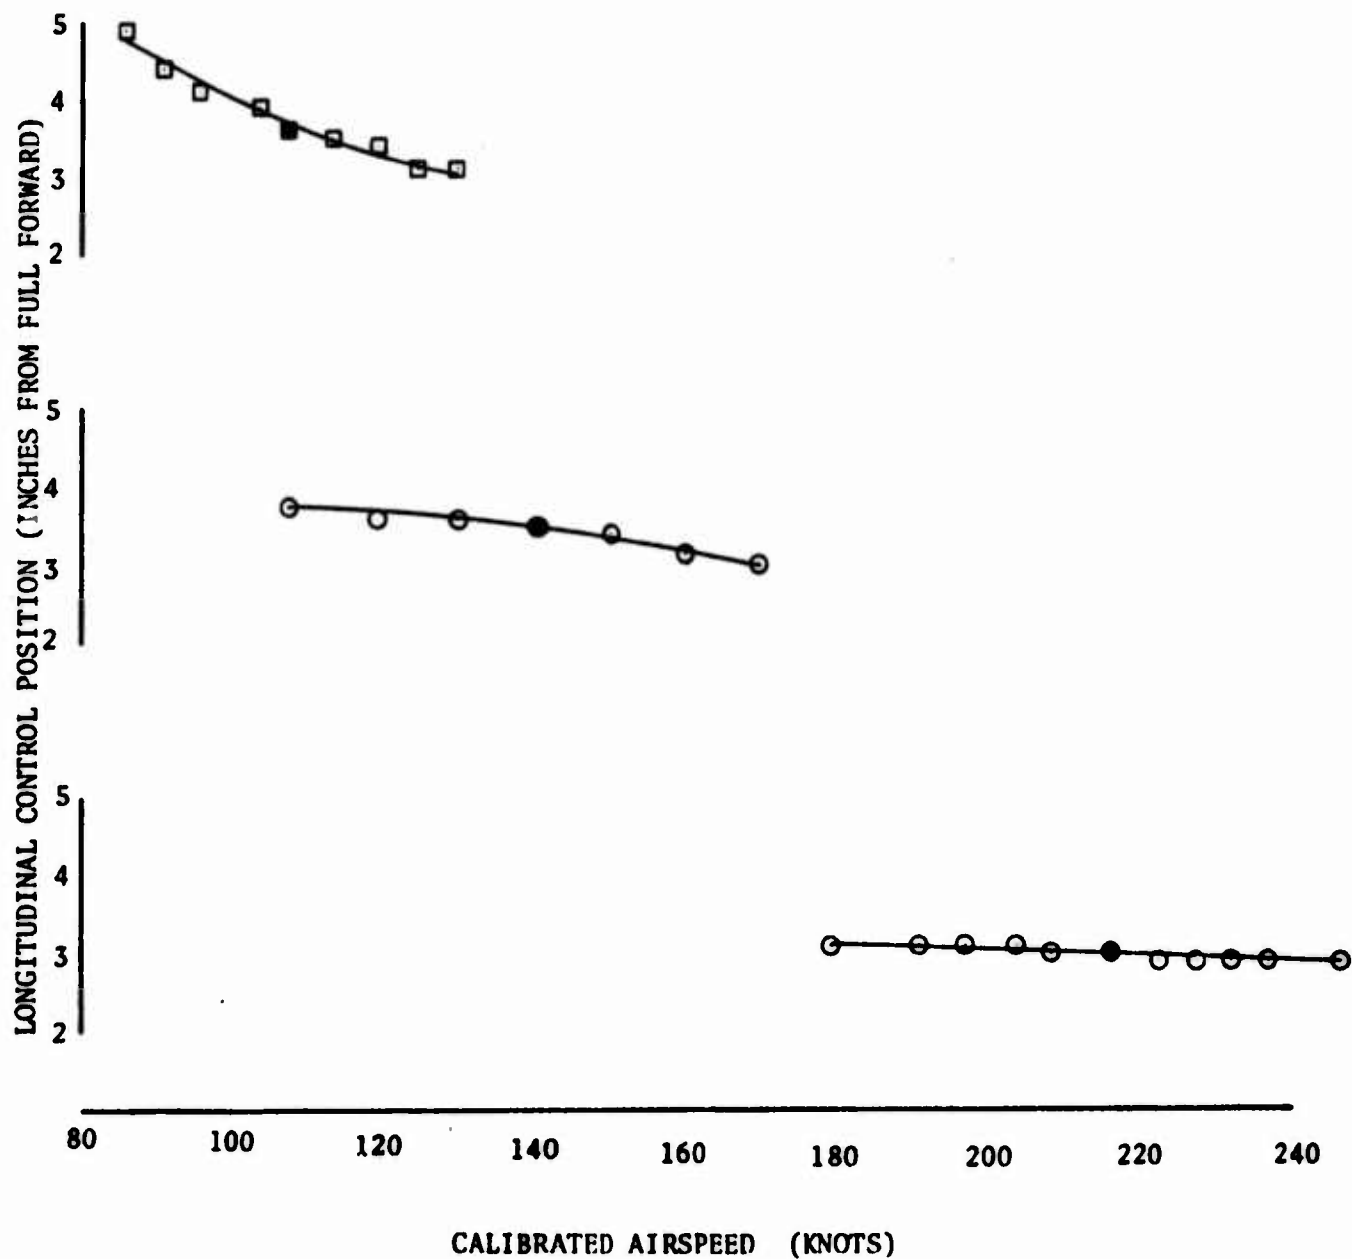
FIGURE 1
 STATIC LONGITUDINAL STABILITY
 RV-1D/QUICK LOOK II
 USA S/N 67-18905

SYMBOL	AVG GROSS WEIGHT (lb)	AVG CG LOCATION (% MAC)	AVG PRESSURE ALTITUDE (ft)	OUTSIDE AIR TEMP (°C)	CONFIGURATION
○	15220	28.7 (AFT)	8000	5°	CR
□	15220	28.7 (AFT)	8000	5°	PA 1

NOTE: Shaded symbols denote trim.
 Full longitudinal control travel = 11.6 inches.

incremental airspeeds greater than and less than the trim airspeed. Control positions were measured and control forces were estimated by the pilot. The quantitative test results are presented in figure 1, appendix C.

12. The elevator control force versus airspeed gradients were qualitatively evaluated by the pilot to be positive about all trim airspeeds in the CR and PA1 configurations. The elevator control position versus airspeed gradients were positive except at 216 knots calibrated airspeed (KCAS), where the gradient was neutral. Although the force and displacement gradients were shallow to neutral, adequate cues are available for satisfactory airspeed control. Within the scope of this test, the static longitudinal stability of the RV-1D/Quick Look II aircraft is satisfactory.

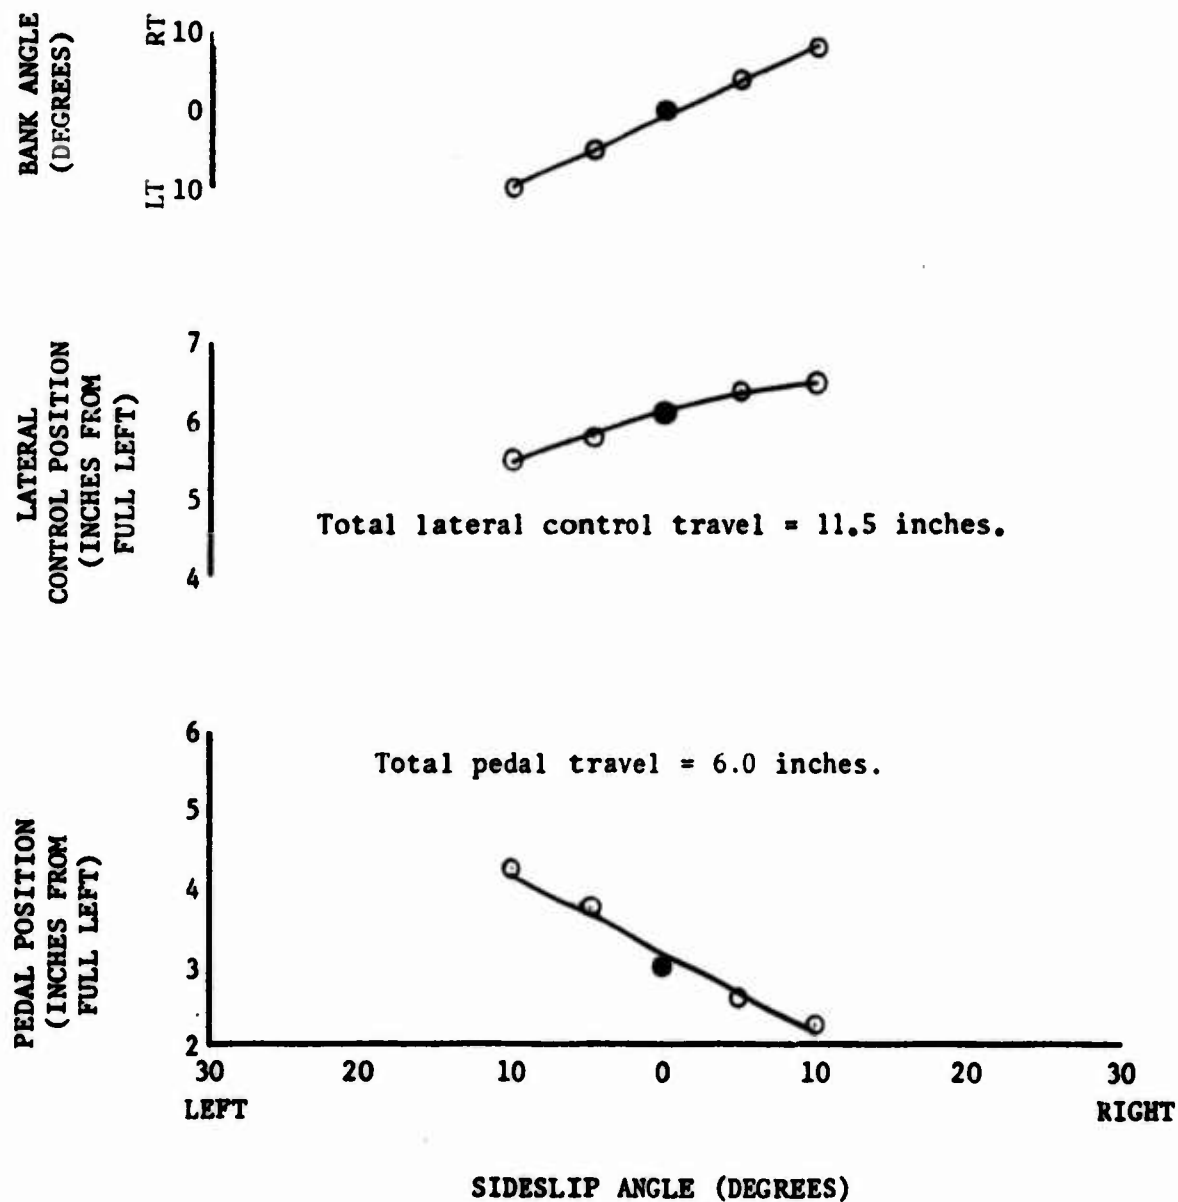
FIGURE 2
 STATIC LATERAL-DIRECTIONAL STABILITY
 RV-1D/QUICK LOOK II
 USA S/N 67-18905

AVG GROSS WEIGHT (lb)	AVG CG LOCATION (% MAC)	AVG PRESSURE ALTITUDE (ft)	OUTSIDE AIR TEMP (°C)	TRIM CALIB. AIRSPEED (KT)	CONFIGURATION
15890	28.7 (AFT)	8000	6	218	CR

NOTE: Shaded symbols denote trim.

13. The static lateral-directional stability characteristics were evaluated at the conditions presented in table 1. The aircraft was initially trimmed for steady-heading, coordinated level flight at the desired trim airspeed. The heading was then incrementally varied while maintaining trim airspeed, constant ground track, and constant power. In each case, the maximum sideslip angle obtained was limited by the pedal force required. Test results are presented in figures 2 through 4, appendix C.

14. The side-force characteristics, as indicated by the variation of bank angle with sideslip angle, were positive and essentially linear. Dihedral effect, as indicated by the variation of aileron control displacement with sideslip angle, was positive. The static directional stability, as indicated by the variation of sideslip angle with rudder pedal deflection and rudder pedal force, was positive for the conditions tested. A nonlinear variation of rudder pedal deflection with sideslip was present in the PA1 configuration at 108 KCAS, but was not objectionable. Within the scope of this test, the static lateral-directional stability characteristics of the RV-1D/Quick Look II aircraft are satisfactory.

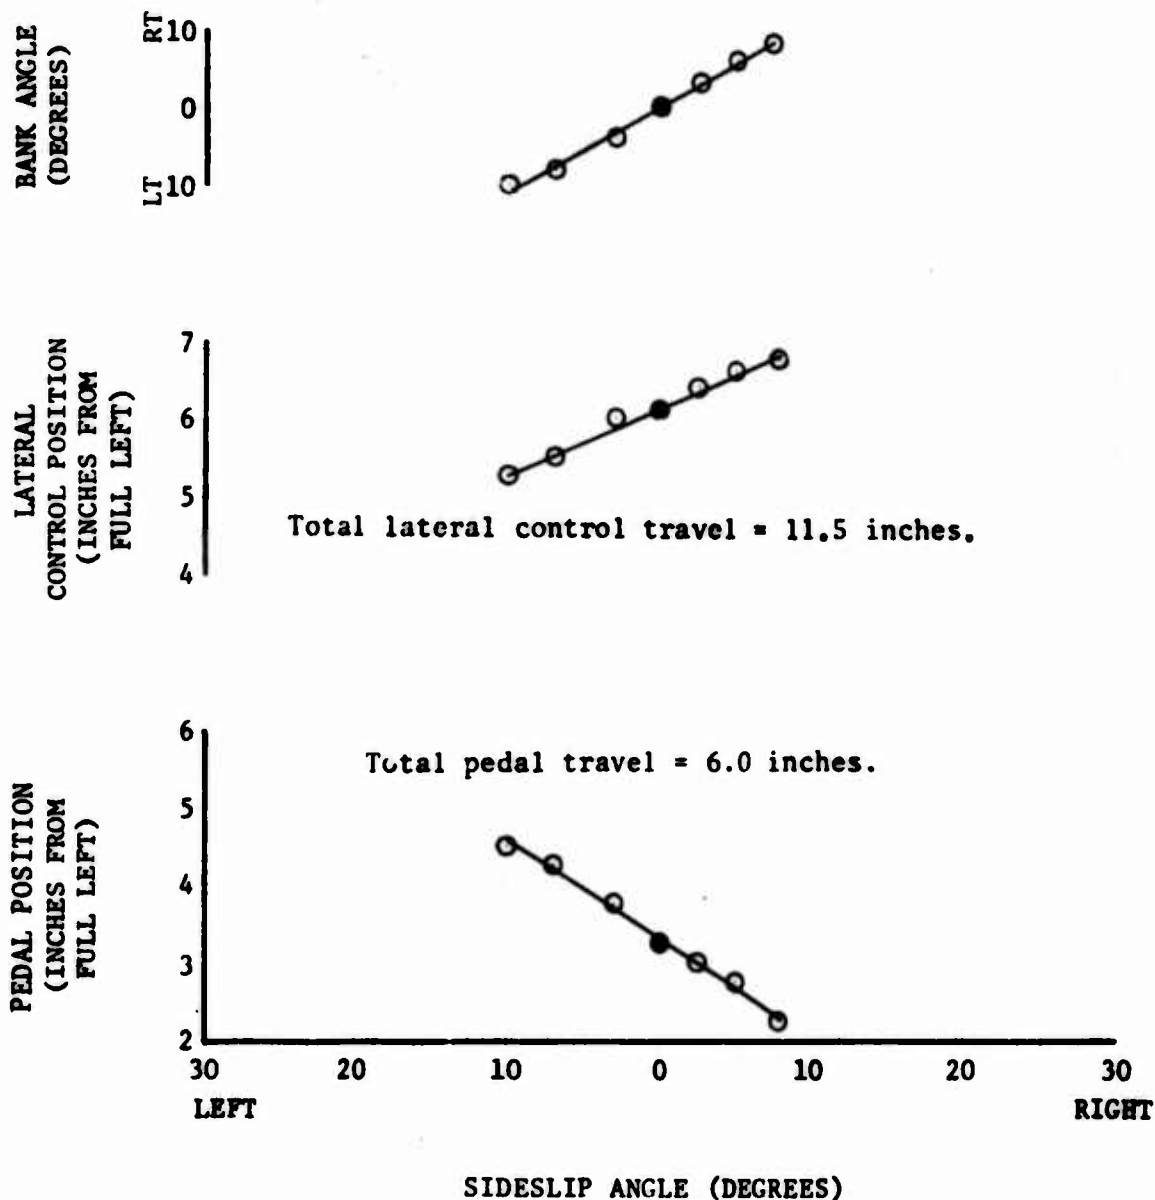
FIGURE 3
STATIC LATERAL-DIRECTIONAL STABILITY
RV-1D/QUICK LOOK II
USA S/N 67-18905

AVG GROSS WEIGHT (lb)	AVG CG LOCATION (% MAC)	AVG PRESSURE ALTITUDE (ft)	OUTSIDE AIR TEMP (°C)	TRIM CALIB. AIRSPEED (KT)	CONFIGURATION
15680	28.7(AFT)	8000	6	140	CR

NOTE: Shaded symbols denote trim.

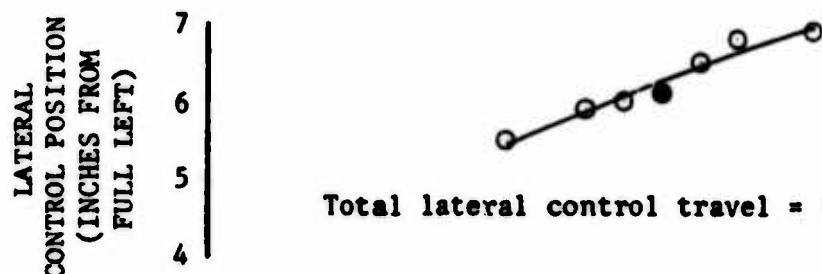
FIGURE 4
STATIC LATERAL-DIRECTIONAL STABILITY
RV-1D/QUICK LOOK II
USA S/N 67-18905

AVG GROSS WEIGHT (lb)	AVG CG LOCATION (% MAC)	AVG PRESSURE ALTITUDE (ft)	OUTSIDE AIR TEMP (°C)	TRIM CALIB. AIRSPEED (KT)	CONFIGURATION
16170	28.8(AFT)	8000	6	108	PAI

NOTE: Shaded symbols denote trim.

Total lateral control travel = 11.5 inches.

Total pedal travel = 6.0 inches.

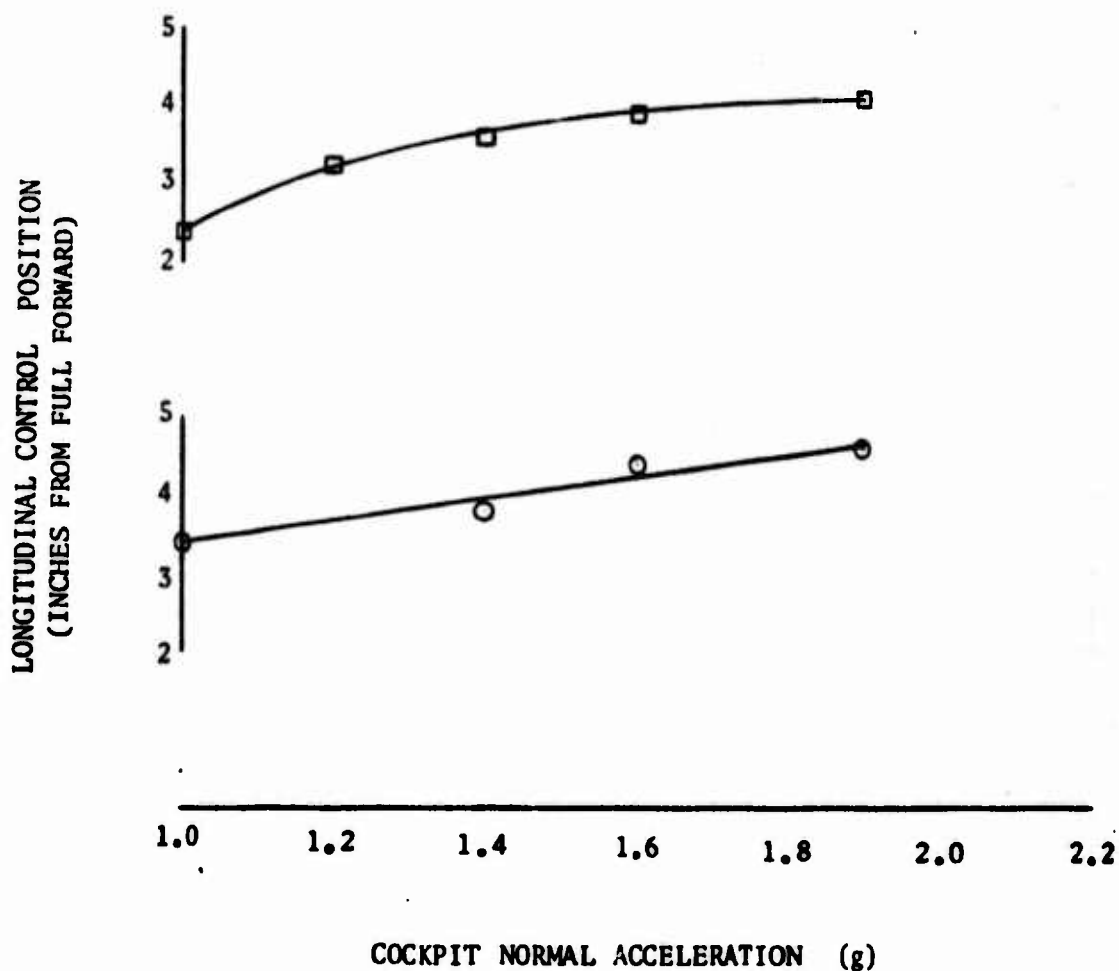
FIGURE 5
MANEUVERING STABILITY
RV-1D/QUICK LOOK II
USA S/N 67-18905

AVG GROSS WEIGHT (1b)	AVG CG LOCATION (% MAC)	AVG PRESSURE ALTITUDE (ft)	OUTSIDE AIR TEMP (°C)	TRIM CALIB AIRSPEED (KT)
16090	28.8 (AFT)	8000	6°	140

- NOTES: 1. Circles denote CR configuration.
2. Squares denote PAI configuration.
3. Full longitudinal control travel = 11.6 inches.

15. The maneuvering stability characteristics were evaluated at the conditions shown in table 1. The airplane was trimmed in wings-level flight at 140 KIAS. The trim airspeed and power setting were maintained constant as the bank angle was gradually increased until the desired normal load factor was reached. Stick-fixed maneuvering stability data are presented in figure 5, appendix C. The control position versus normal acceleration gradients were positive for CR and PA1 configurations. The stick-free maneuvering stability was qualitatively evaluated to be positive (increasing aft control force with increasing normal acceleration) for the conditions tested. A decreasing position gradient with increasing load factor was apparent in the PA1 configuration; however, it was not objectionable. The increasing aft control force required provided sufficient pilot cues of increasing load factor during steady-state maneuvering. However, during qualitative tests involving rapid left and right rolling maneuvers at airspeeds less than 140 KIAS, insufficient control position and force cues were present to warn the pilot of

increasing load factor. As discussed in paragraph 21, the high lateral control forces are not compatible with the relatively light longitudinal forces. During these tests, the pilot was required to closely monitor the load factor indicator to avoid exceeding the flight envelope. A normal load factor indicator is therefore required to prevent unintentionally exceeding the flight envelope during rapid rolls at airspeeds less than 140 KIAS. Except during rapid rolling maneuvers at low airspeeds, maneuvering stability of the RV-1D/Quick Look II aircraft is satisfactory.
